## Flat Roof Leak Repair Flat Roof In Minneapolis Leaked for Years and Copper Was the Answer

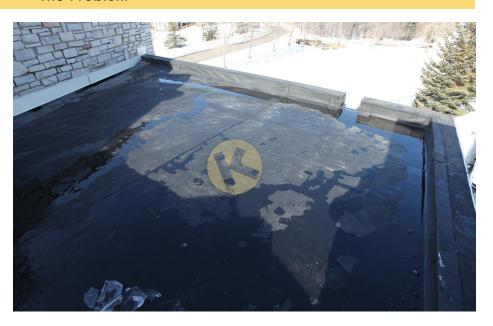
The demands placed on flat roofs in Minneapolis create a unique set of challenges to even the most robust systems. The flat roof here was a 10 year old rubber membrane roof (aka, EPDM). Over the past few years as the leaks got worse and worse our client had a few contractors attempt to fix the problem. By the time we arrived it was clearly a case where total replacement was warranted.

As with most residential construction challenges, proper diagnosis of the problem is the best place to start. We used our thermal imager after a long rain storm to look into the ceiling. The resulting images indicated three separate leaks, confirming the idea that roof replacement was smarter than repair.

We gave our client two material options including TPO membrane and copper. They choose copper because this roof was visible from the master suite and they wanted a touch of architectural character. Years later the roof is still leak free.

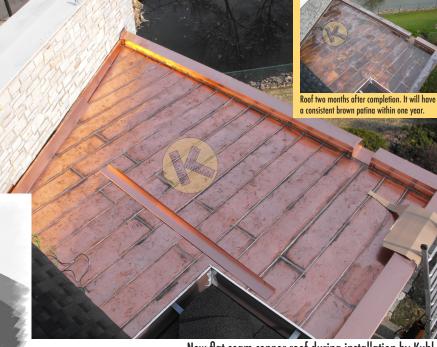
New flat seam copper roof during installation by Kuhl.
