# **CASE STUDY**

## Solving the Mystery Leak

A Leaking Home Gets Fixed for Good

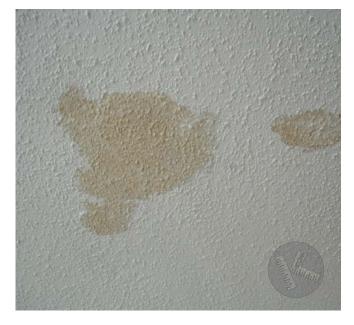
#### The Problem

Our clients, homeowners in Eden Prairie, had a mysterious water spot on the ceiling of their dining room. It clearly was related to rain because there was no plumbing in the vicinity and the damage appeared after one of those long, soaking storms. Their original builder offered to come out and take a look and he found what he thought was the problem in a few minutes, that the leak was originating around one of two roof vents near the peak of the roof (1 and 2 in below, left photo). We were asked to render our opinion the next day. The problem was easy to find and it had nothing to do with the vents.

The solution was a rather cheap repair to the ridge of this medium hand-split cedar shake roof. Now, keeping the squirrels off the roof is another matter altogether.

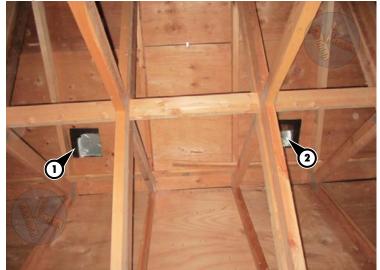
# Lights On.

The builder made a common mistake: he flipped the lights on in the attic so he could do the best inspection possible. Seems logical enough. But we have learned it is always smart to take some time in the dark up there to see things otherwise hidden. In this case, the hidden thing was a small hole chewed in the roof between the two vents (f'ing squirrels!). A visual inspection of the roof confirmed this assessment. Dork alert: We took this excellent photo of the hole by holding our camera against a framing member on leaving the shutter open for a long exposure. Not that we are geeks about this sort of thing. But seriously, how cool is that photo?
