## Putting the K back in Copper

Fixing a leaking chimney, replacing a cedar roof

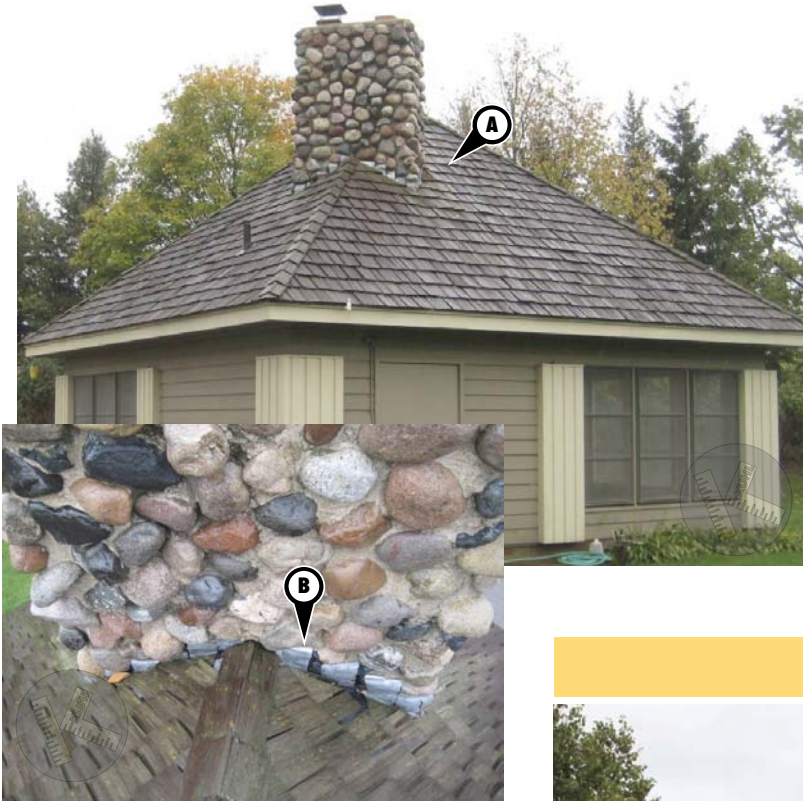
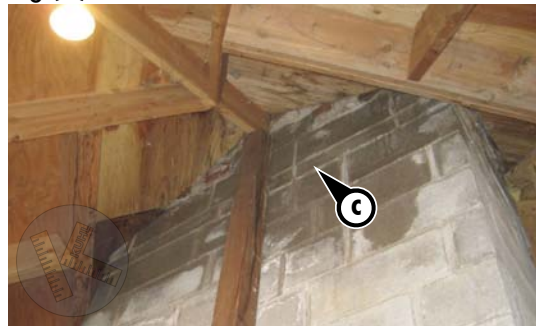
This is the community building owned by an exclusive neighborhood association in Orono. For years different roofers were hired to address the leaking chimney (A), only to ultimately fail in their attempts. Their answer, caulk and tar (B). Here is the pesky leak as seen from the mechanical room of the building (C).
