KUHL CASE #06

Solving Ice Dams In Minneapolis
Science + Common Sense + Insulation & Ventilation = No Ice Dams

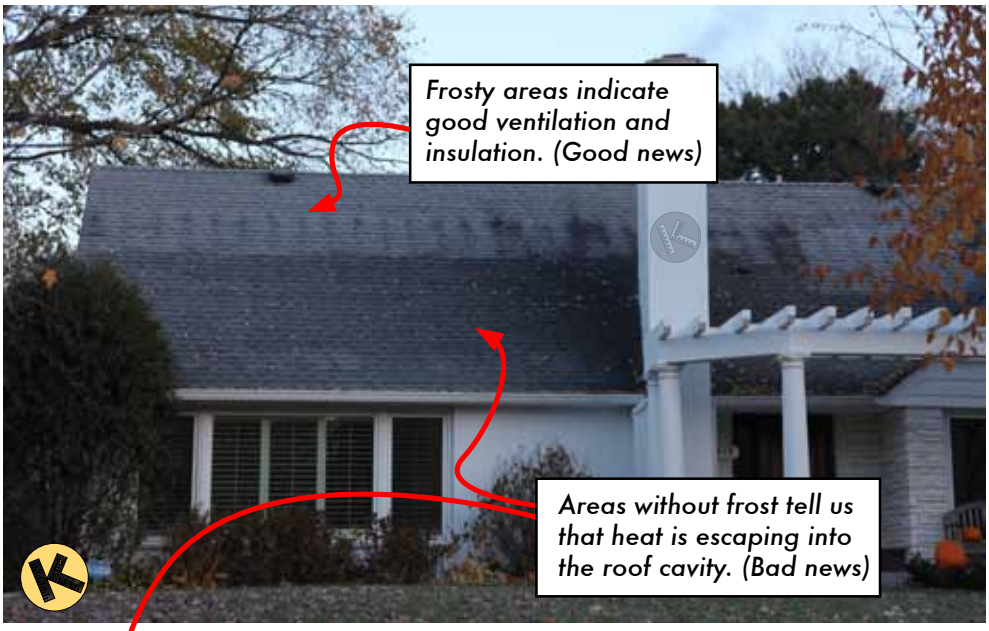
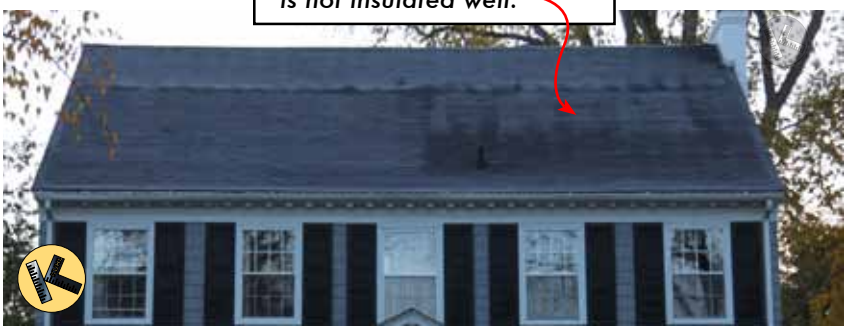
Frost Melt Patterns
At their most fundamental level, ice dams are the result of the interaction of heat loss and snow on your roof. An experienced Kuhl Thermographer can use photos like these in conjunction with infrared imaging to see the weak points in your homes thermal envelope. If you have a moment on the next frosty morning, take a few photos of your roof from a few angles before the sun hits it. Those photos may end up saving you time and money if you are hoping to fix the root cause of ice dams and home heating inefficiencies.

Infrared imaging confirms what Jack Frost already told us.
