KUHL CASE #18

Leaking Stucco Chimney Solution

Stucco Home in Eden Prairie Has Damage That Needed Fixing

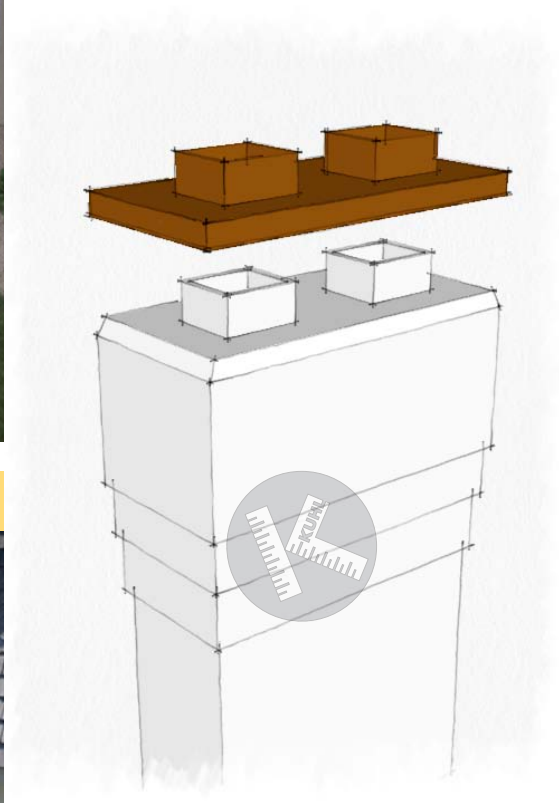
The cap of the original chimney had a sloped mortar core with a top coat of stucco (portland cement). Bad idea. We don't like stucco to be used on horizontal surfaces unless particular steps are taken. Water was leaking down into the chimney column and causing trouble below. Instead of rebuilding the upper portion of the chimney (big bucks) we advised our client to cover the existing cap with a custom copper chimney cap.

Many Kuhl solutions, such as this one, are based on a rendering produced specifically for each job. We would rather work out the details on the laptop than at your home as the work is underway. Plus, renderings allow us to have a conversation about design possibilites before any work begins.

The copper chimney cap we built for this home cost roughly $1,200 to fabricate and install.
