CASE STUDY
KUHL SOLUTIONS TO CLIENT PROBLEMS

KUHL CASE #43

Animals in Minneapolis Roof Vents (Part 1)
How to Keep Birds, Bats, Mice and Squirrels Out of Your Home

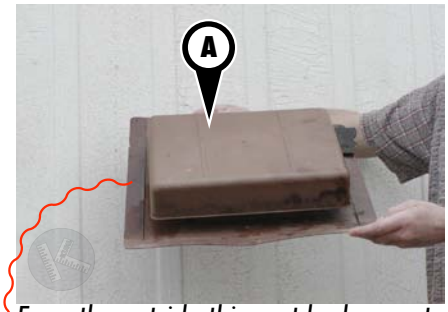
From the outside this vent looks great.

Look inside to see things are not great.

The solution to animals getting into an attic through cheesy roof vents is to replace them all with metal, louvered vents (above). Most homes have an average of 9-14 vents on the roof. Even if only one or two of your existing vents have critter problems you must replace every vent on the roof if you want to solve the problem.

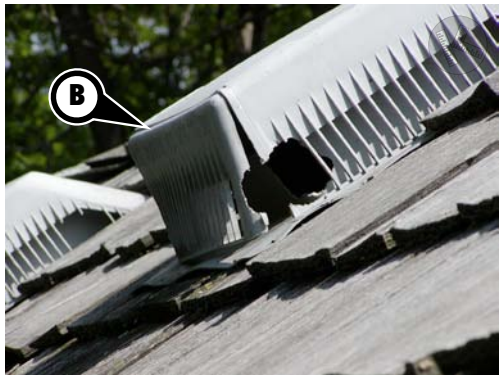
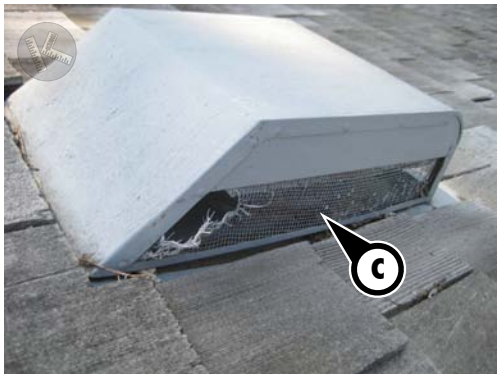
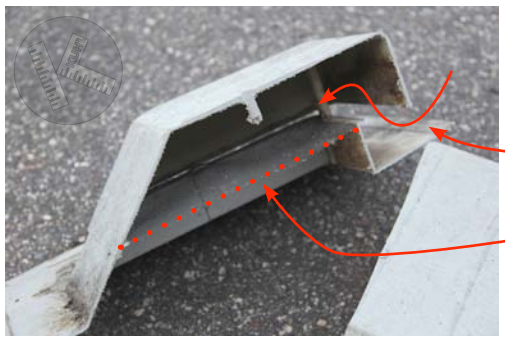
If you have lousy roof vents don't feel bad. About 60% of the roofs in Minneapolis that we inspect do. There are three common types of crappy roof vents in Minnesota:
1) Plastic turtle-style (A)
2) Plastic louvered (B)
3) Non-louvered metal vents (C)

We took a typical plastic roof vent to a band saw and sliced it in half. (Yes, we are geeks). Here are the fatal flaws that are exposed within:

Design allows animals to crawl under the hood and onto the screen where they either nest or enter the home.

Layer of screen is made of lightweight aluminum. Animals chew through it with ease (below).

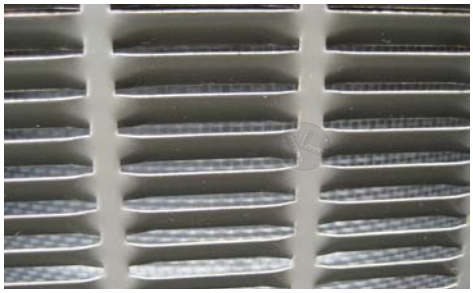
Up close look at the metal louvers
